**BLISTERING OF GRAPHITE/POLYMER COMPOSITES GALVANICALLY  
COUPLED WITH METALS IN SEA WATER**

**Materials Laboratory, College of Engineering  
The University of Rhode Island**

**AN ANNUAL REPORT**

**ONR Contract # N0001491J1328**

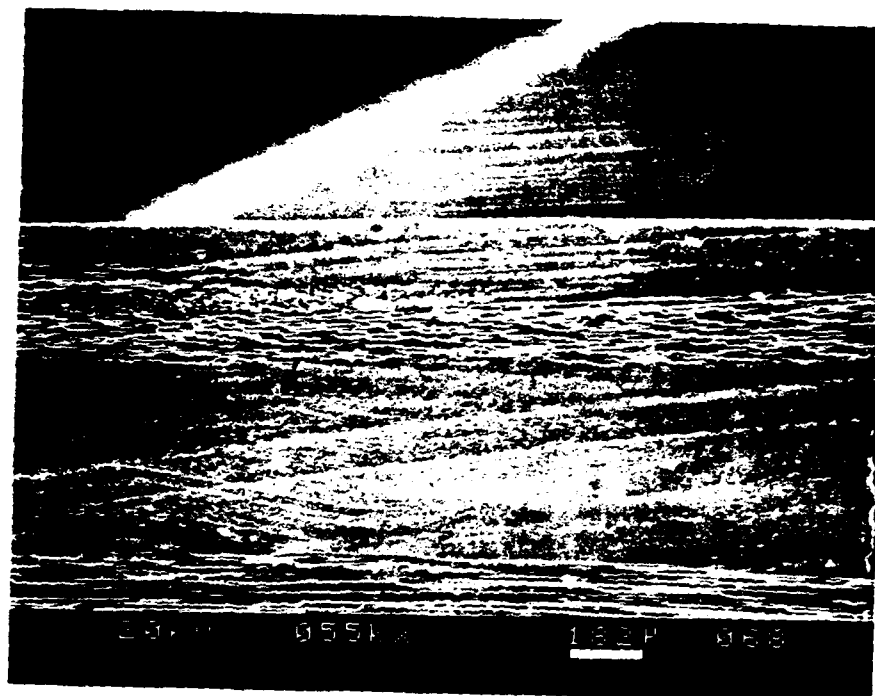
An SEM morphological study was conducted of the blisters. Figure [7a] shows a vertical section through a blister. The bright line running horizontally is the composite resin-rich surface. Below this line, a less brighter band (containing dashed lines) also running horizontally is the carbon fiber tow. Glass fibers can be seen as tiny dots (some of these glow due to charging) to the left side of the micrograph and just above the carbon fiber tow. To the right an opening along the carbon/matrix interface can be seen. This is the blister opening.

Figure [7b] shows this blister opening at a higher magnification. It clearly reveals that the blister opening occurred at fiber/matrix interface. However, a few fibers are seen attached to the blister cap. Actually, the blister opening occurs within the carbon fiber bundle but at the fiber/polymer interface.

Figure [7a] also shows that the interface crack proceeded below the glass fiber bundle. The fiberglass tows are unaffected by blisters. Figure [8a] supports this

Figures 7a, 7b. SEM micrographs showing delamination at the carbon/matrix interface in carbon/glass/vinyl ester composite.

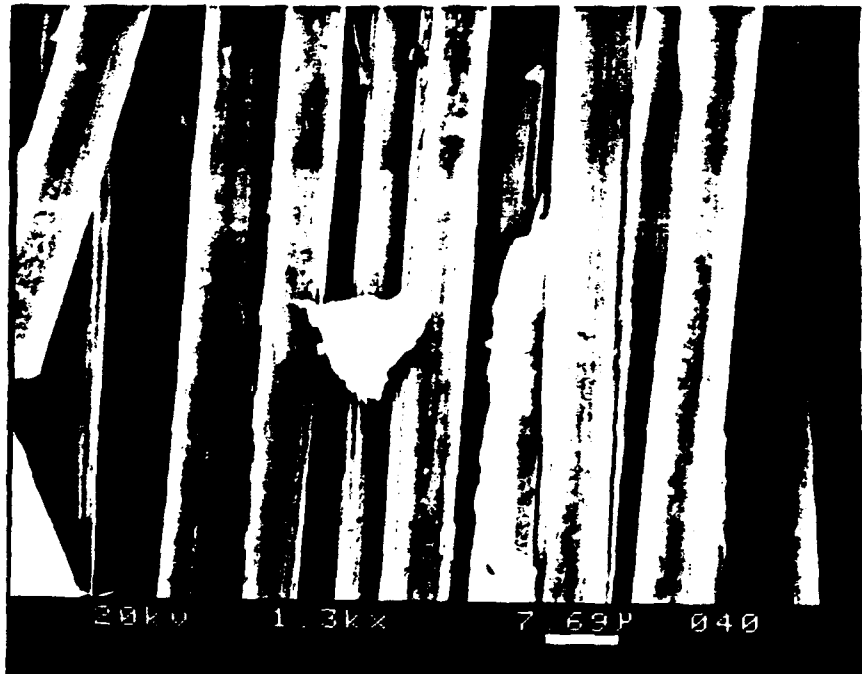
Figure 8b. SEM micrograph showing magnified view of the carbon fibers seen in the blister of Figure 8a.
